SAMEDAN LSZS  
VISUAL APCH WITH RNP GUIDANCE RWY 03  
9.1° OFFSET LEFT  
ACFT CAT A/B/C

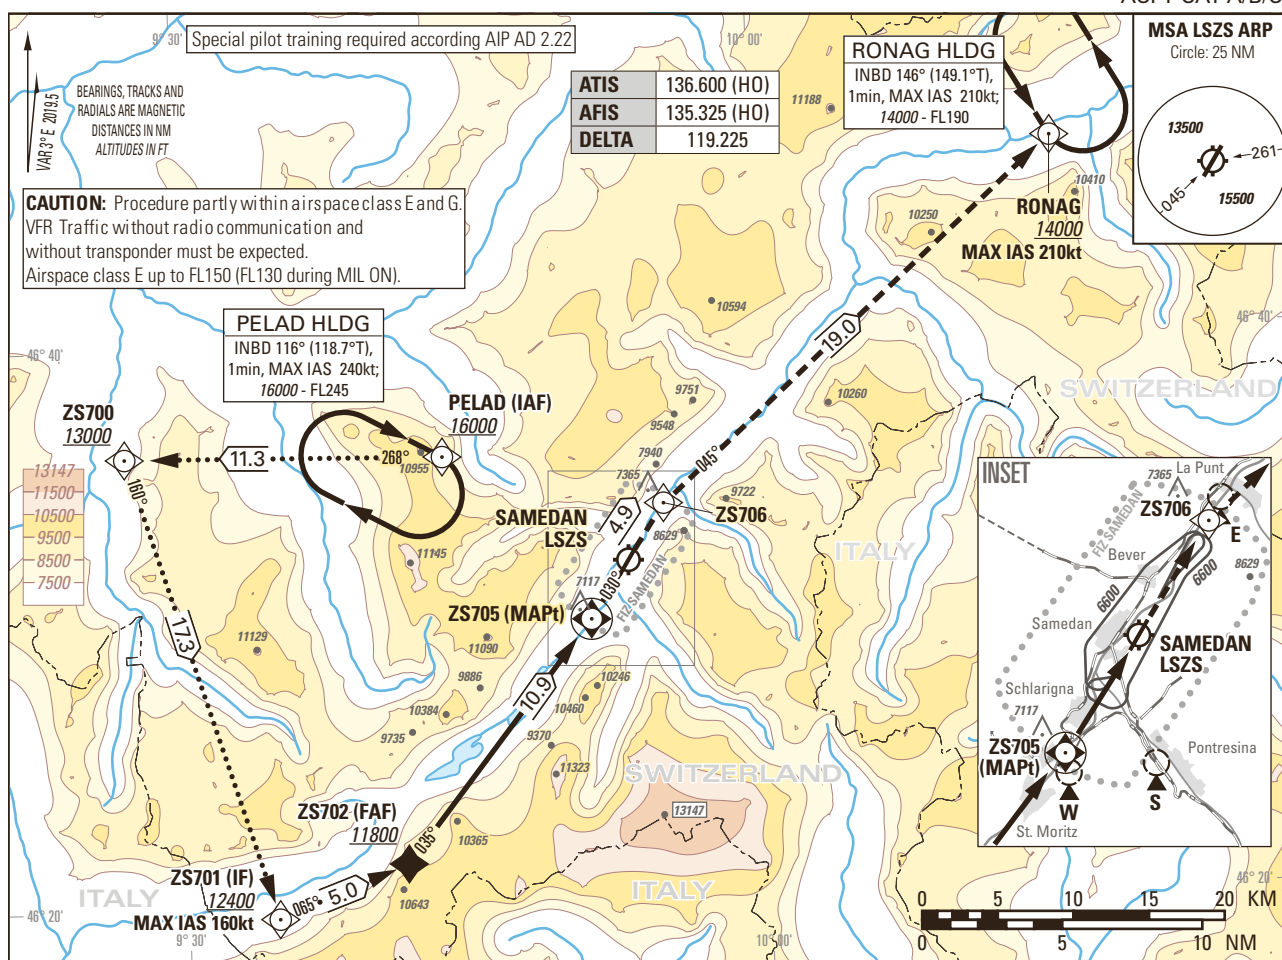
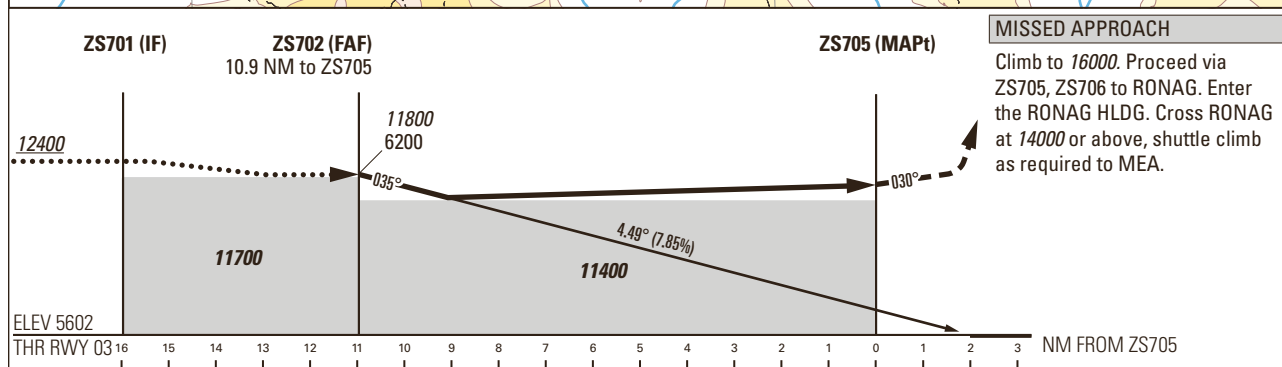
- ROD 1000ft/min exceeded with GS > 125kt in final approach.
- Approach clearance includes the clearance to leave and re-enter controlled airspace.
- ICAO obstacle protection surface penetrated by a hill BTN ZS705 and THR 03.
- PAPI at 4.49°
