SAMEDAN LSZS  
VISUAL APCH WITH RNP GUIDANCE RWY 03  
9.1° OFFSET LEFT  
ACFT CAT A/B/C

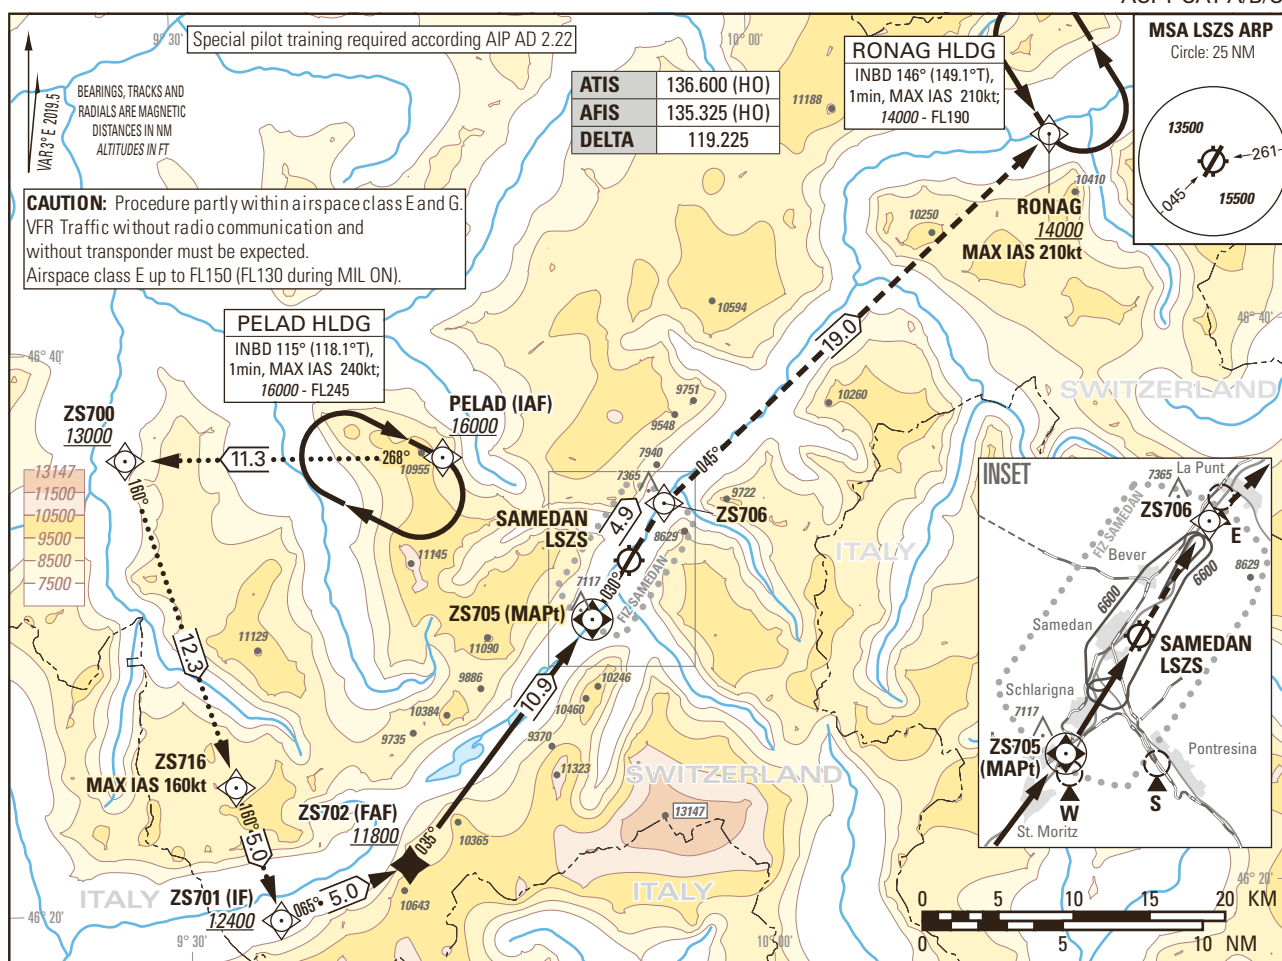
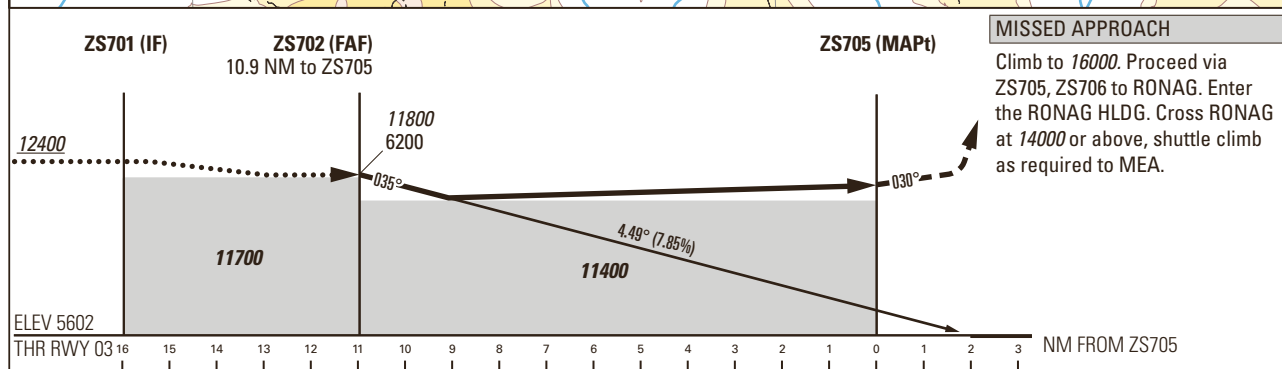
- ROD 1000ft/min exceeded with GS > 125kt in final approach.
- Approach clearance includes the clearance to leave and re-enter controlled airspace.
- ICAO obstacle protection surface penetrated by a hill BTN ZS705 and THR 03.
- PAPI at 4.49°

- Altitude adjustments for cold temperature conditions required by the flight crew.
