Instrument Approach Chart  
(IAC)

TRANSITION LEVEL by ATC  
TRANSITION ALTITUDE 16000SAMEDAN (LSZS)  
VISUAL APCH WITH RNP GUIDANCE RWY 03

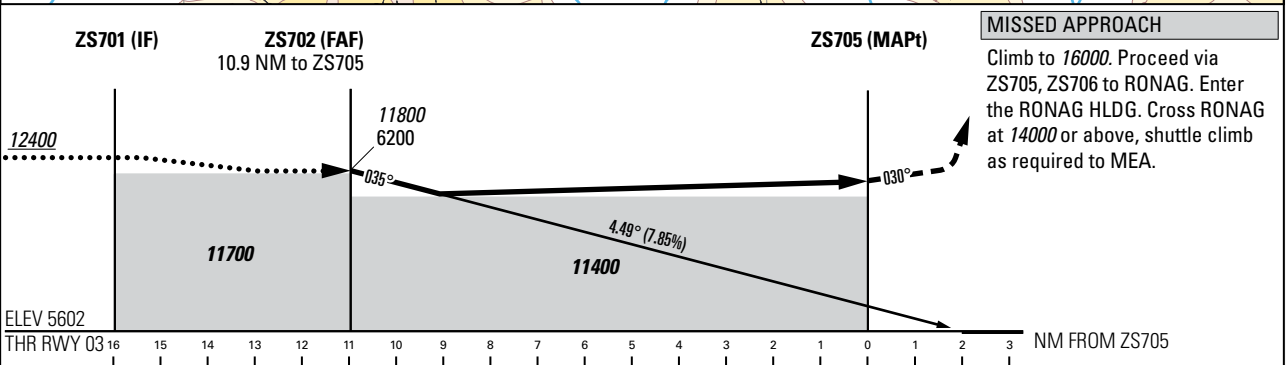
| Missed APCH<br>climb gradient<br>requirement | NON-ALIGNED VISUAL APCH<br>WITH RNP TRACK GUIDANCE | | | ROD | GS kt | 80 | 100 | 120 | 140 | 160 | 180 |
| | | | | | FT/MIN | 636 | 795 | 954 | 1113 | 1272 | 1431 |
| | A | B | C | DIST ZS705 | 10.9 | 10 | 9 | 8 | 7 | 6 | 5 |
| | MDA(H) | | | DIST THR | 12.9 | 12 | 11 | 10 | 9 | 8 | 7 |
| 2.5% | 11400 (5798) | | | ALT FT | 11800 | 11370 | 10890 | 10420 | 9940 | 9460 | 8980 |
