Instrument Approach Chart  
(IAC)

TRANSITION LEVEL by ATC  
TRANSITION ALTITUDE 16000SAMEDAN (LSZS)  
VISUAL APCH WITH RNP GUIDANCE RWY 03

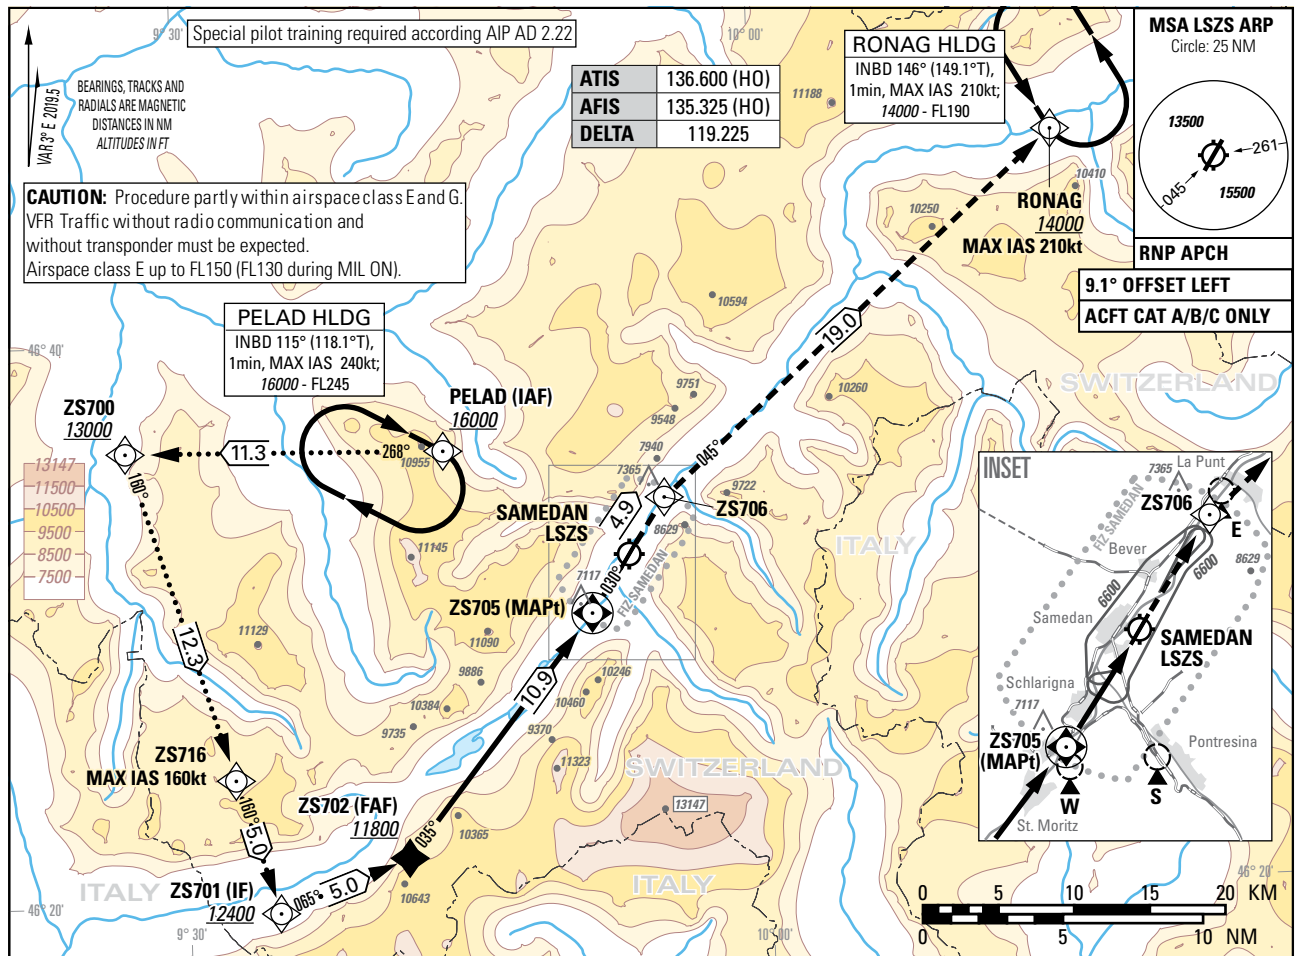
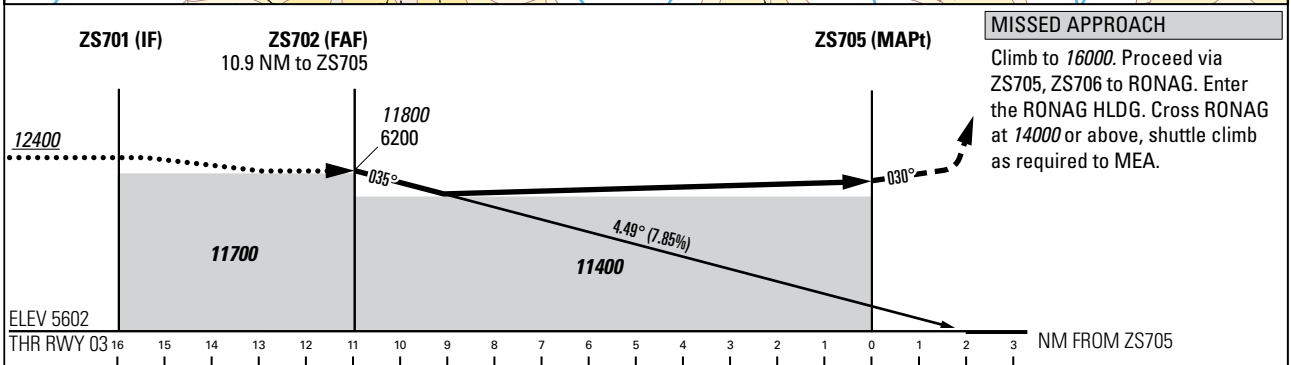
| Missed APCH<br>climb gradient<br>requirement | NON-ALIGNED VISUAL APCH<br>WITH RNP TRACK GUIDANCE | | |
| | A | B | C |
| 2.5% | MDA(H)<br>11400 (5798) | | |

| ROD | GS kt | 80 | 100 | 120 | 140 | 160 | 180 |
| | FT/MIN | 636 | 795 | 954 | 1113 | 1272 | 1431 |
| DIST ZS705 | | 10.9 | 10 | 9 | 8 | 7 | 6 |
| DIST THR | | 12.9 | 12 | 11 | 10 | 9 | 8 |
| ALT FT | | 11800 | 11370 | 10890 | 10420 | 9940 | 9460 |

- ROD 1000ft/min exceeded with GS > 125kt in final approach.
- Approach clearance includes the clearance to leave and re-enter controlled airspace.
- ICAO obstacle protection surface penetrated by a hill BTN ZS705 and THR 03.
- PAPI at 4.49°.
