Instrument Approach Chart
(IAC) - ICAO

SAMEDAN LSZS
VISUAL APCH WITH RNP GUIDANCE RWY 03
9.1° OFFSET LEFT
ACFT CAT A/B/C

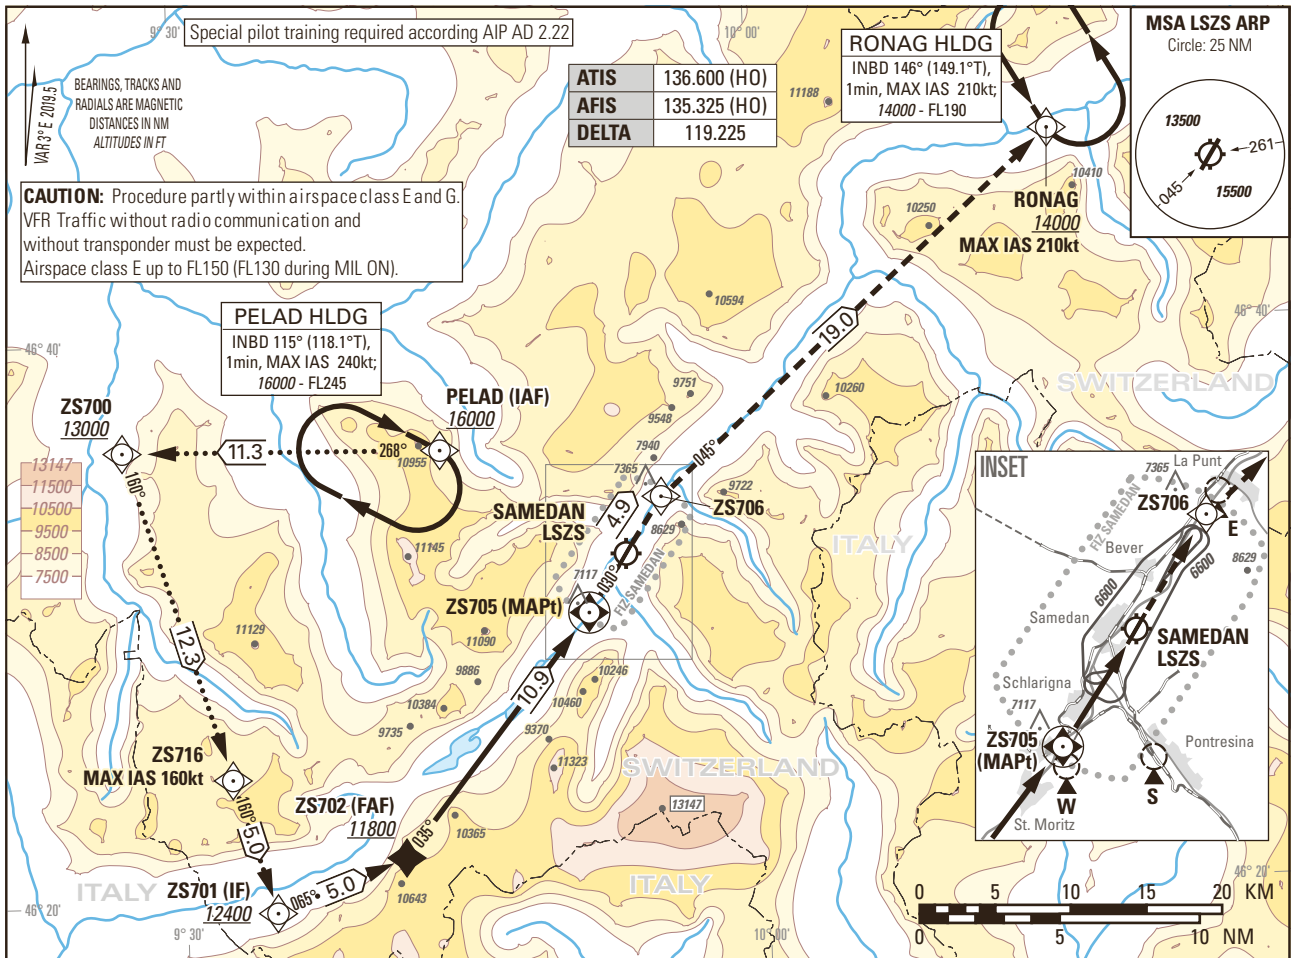
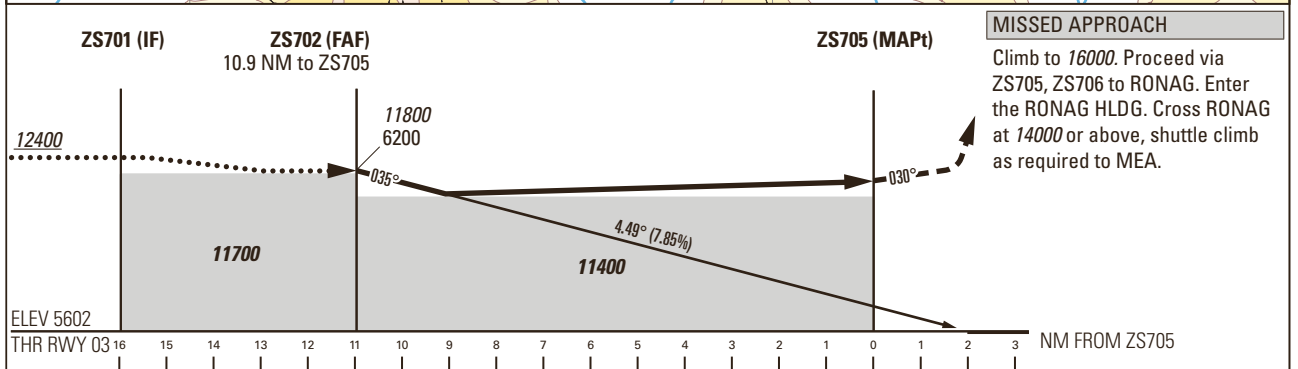
Missed APCH climb gradient requirement	NON-ALIGNED VISUAL APCH WITH RNP TRACK GUIDANCE			ROD	GS kt	80	100	120	140	160	180
	A	B	C		FT/MIN	636	795	954	1113	1272	1431
	MDA(H)			DIST ZS705	10.9	10	9	8	7	6	5
2.5%	11400 (5798)			DIST THR	12.9	12	11	10	9	8	7
				ALT FT	11800	11370	10890	10420	9940	9460	8980

REMARK
- ROD 1000ft/min exceeded with GS > 125kt in final approach.
- Approach clearance includes the clearance to leave and re-enter controlled airspace.
- ICAO obstacle protection surface penetrated by a hill BTN ZS705 and THR 03.
- PAPI at 4.49°.
