Instrument Approach Chart  
(IAC)

TRANSITION LEVEL by ATC  
TRANSITION ALTITUDE 16000SAMEDAN (LSZS)  
VISUAL APCH WITH RNP GUIDANCE RWY 03

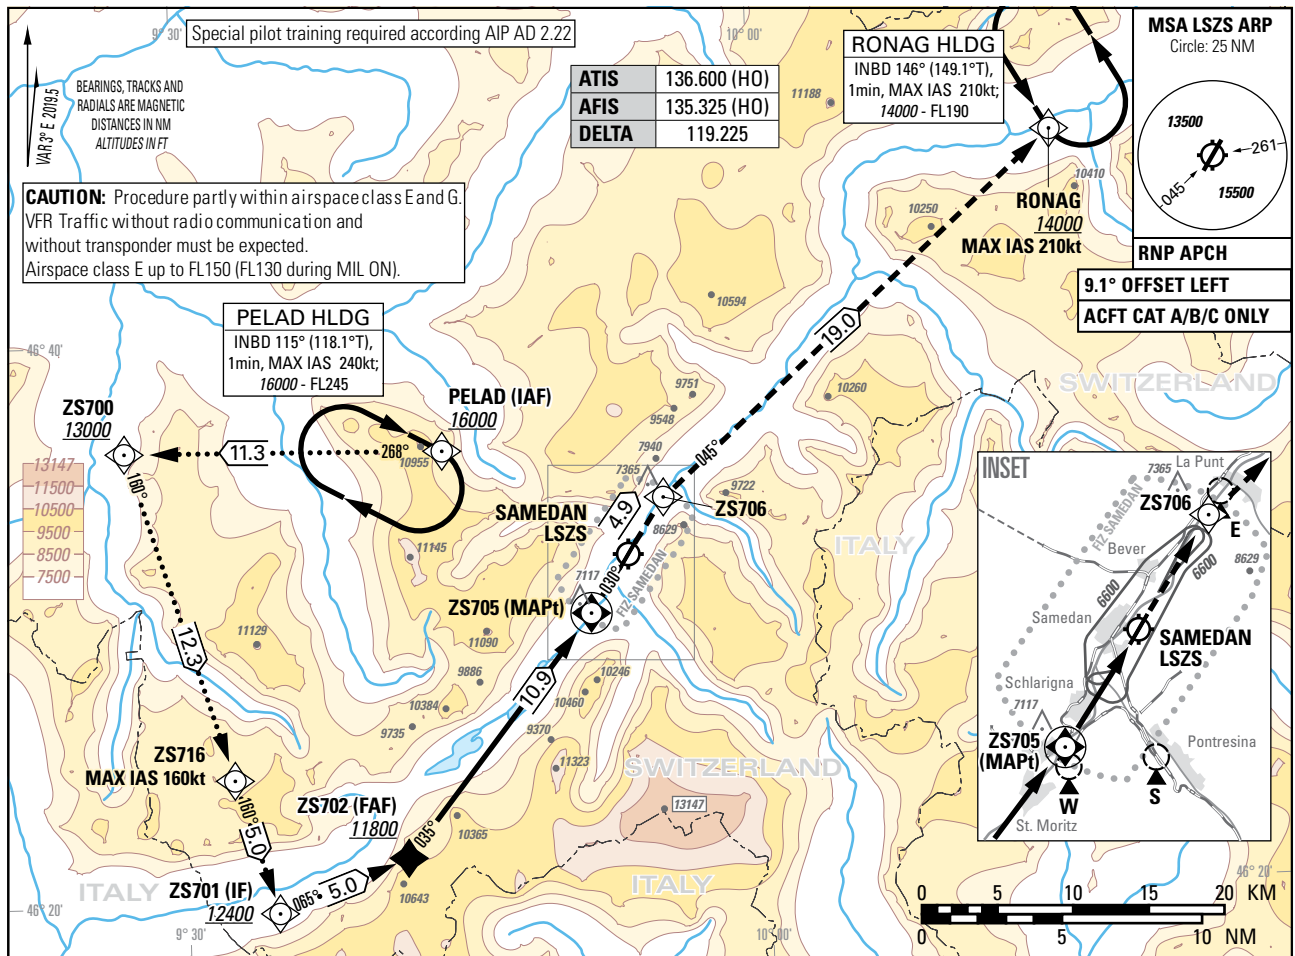
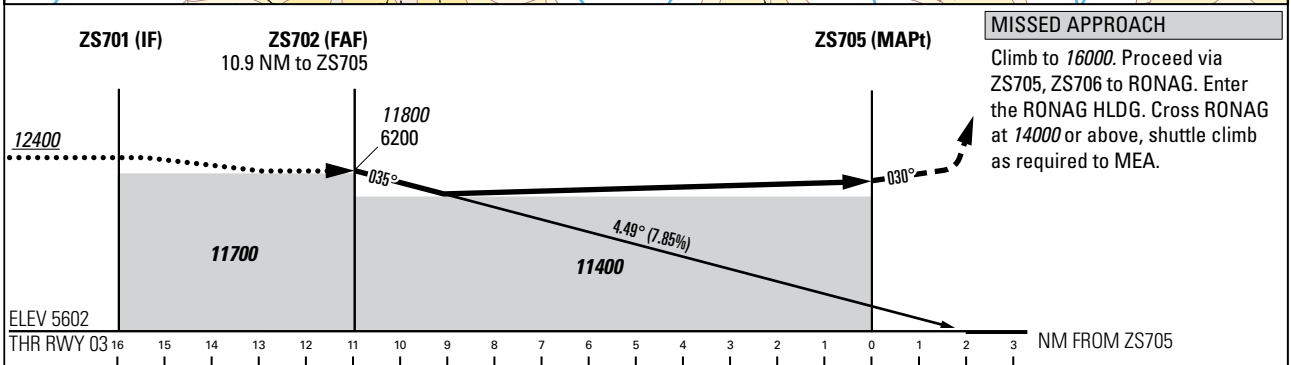
- ROD 1000ft/min exceeded with GS > 125kt in final approach.
- Approach clearance includes the clearance to leave and re-enter controlled airspace.
- ICAO obstacle protection surface penetrated by a hill BTN ZS705 and THR 03.
- PAPI at 4.49°.
