## VISUAL APPROACH PROCEDURE

LUGANO (LSZA)  
CHARLIE CIRCLING RWY 19

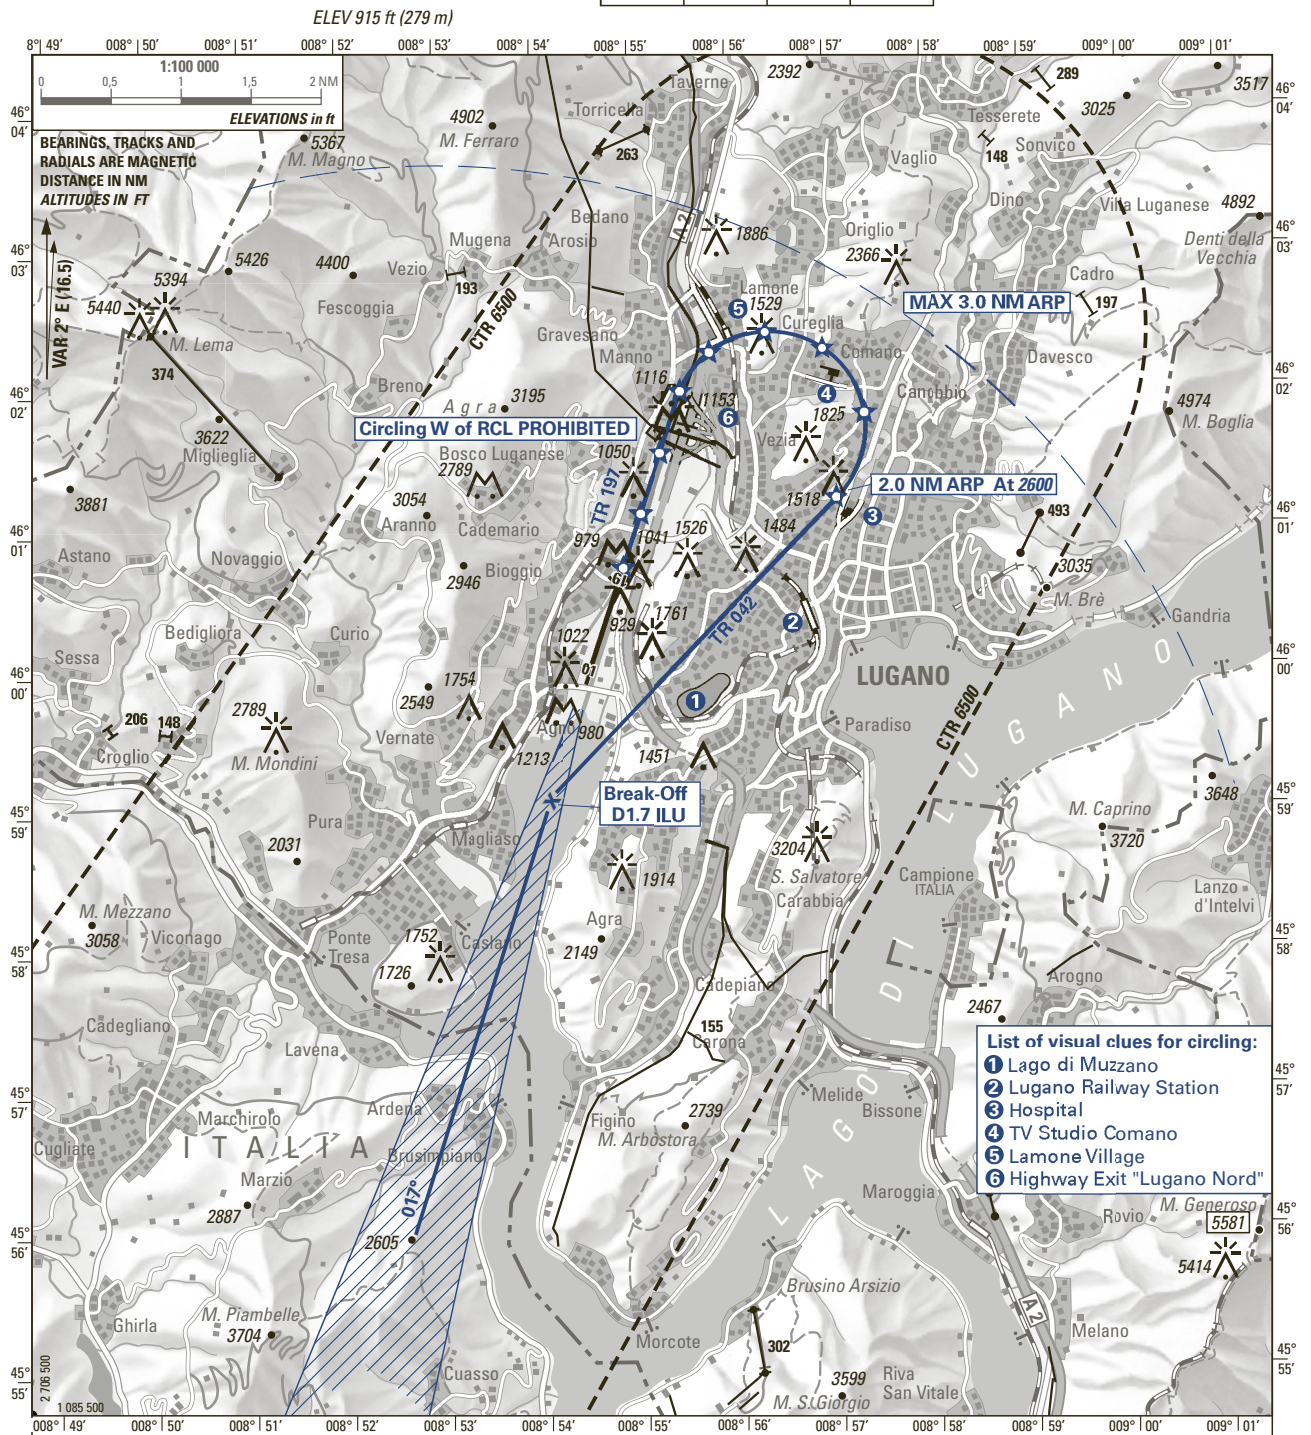
**WARNING:** Disregard PAPI RWY 01 information.

Use PAPI RWY 19 information only within 2 NM from THR

- In case of failure of the RLLS 19, each concerned mast will be numbered on the published NOTAM. Numbering starts with (L1) at the end of the downwind leg and runs until (L9) for last pole before THR 19.
- HN: If RLLS RWY 19 u/s, then no clouds below 3000 ft QNH.

If visual contact is established at D2.2 ILU, continue straight ahead. At D1.7 ILU turn right on track 042° and continue descent visually to 2600 ft.

At 2 NM ARP start left turn onto base.
